## Defining TransNamib's Engineering Future:

A Study on the Establishment of a New Motive Power and Rolling Stock  
Repair Workshop in the Usakos -- Erongo Region of Namibia

An Interactive Qualifying Project submitted to the Faculty of  
WORCESTER POLYTECHNIC INSTITUTE  
in partial fulfilment of the requirements for  
the Degree of Bachelor of Science

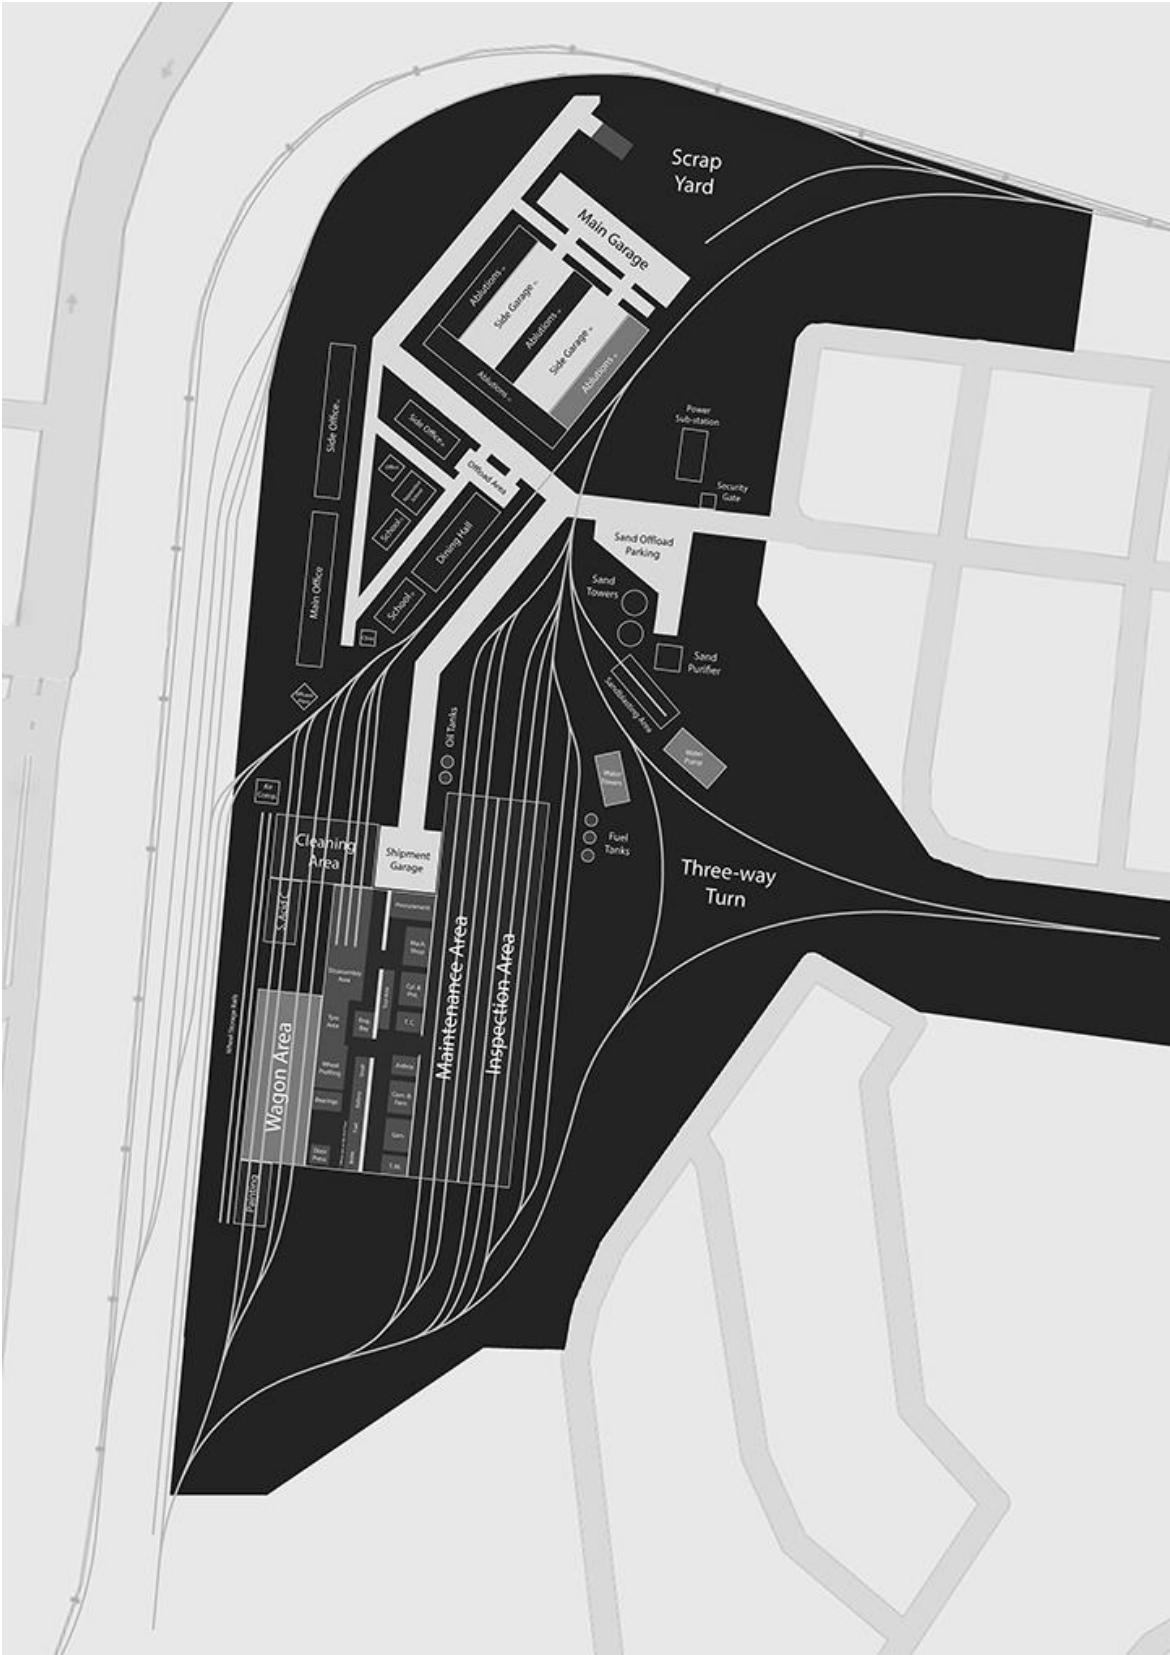
Figure 0.1 - Final Design

The secondary buildings were placed in the northern section of the design area. These buildings include offices for senior engineers and management staff, along with ablutions and a canteen building for workers and a training centre. The design can be seen in Figure 0.1.

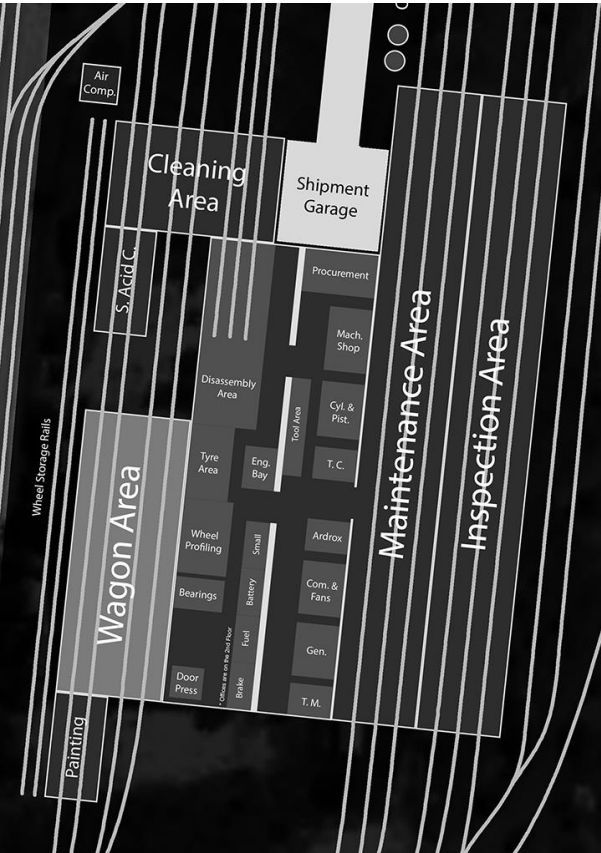
Figure 0.2 - Interior Design

The full internal design is given in Figure 0.2 below. Inside the workshop, two main sections were established for heavy and light repairs. This layout allows for different sized cranes to be utilized and minimizes the needed movement of a locomotive to be repaired. The heavy repair workshop is responsible for full disassembly of locomotives and movement of the engines and wheels. Having a wheel repair section between locomotive and wagon areas allows quick access for both the wagon and locomotive workshops. This is a significant improvement over the Windhoek shop, which had the two sections 120 meters apart from each other. The rest of the heavy repair sections were relocated to maximize the efficiency and lessen the distance to be travelled by crane. The light repair section was built to allow free movement between it and the maintenance platforms. This allows for cranes to carry components from locomotives under maintenance to their respective sub-shops. These shops were then re-organized to ensure they are located next to important ardrex baths for cleaning or required machine shops.

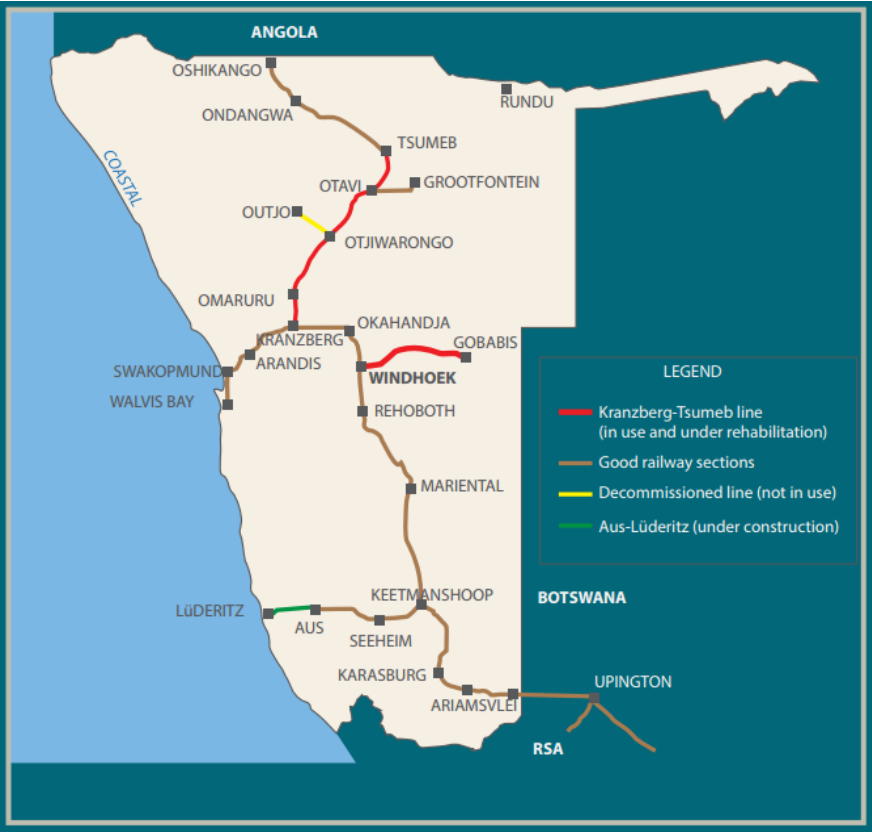
Figure 2.1 - TransNamib Rail Map (2013 Annual Report, 2014)

The first rail line built by Germans in 1897 was created to connect the coastal city Swakopmund to the capital Windhoek. Named “Statsbahn,” the purpose of this line was to establish a trade route to the largest city of Namibia, and prepare a main transportation hub to reach out to the mining areas that mostly lie in the northern region of the country. From 1902 to 1908, hundreds of kilometres of railroad were established to connect social and economic centres of the Namibia to the central rail hub. (Direks, Klaus, 2007) Walvis Bay was added to the transportation hub in 1914. After World War I, South Africa took over Namibia and its railways. This introduced a unified railway system in Southern Africa and increased the importance of Walvis Bay in African trade. The rail lines have continued to expand and now the lines allow for trade to reach most of the country, as the map of the current rail lines is given below in Figure 2.1.

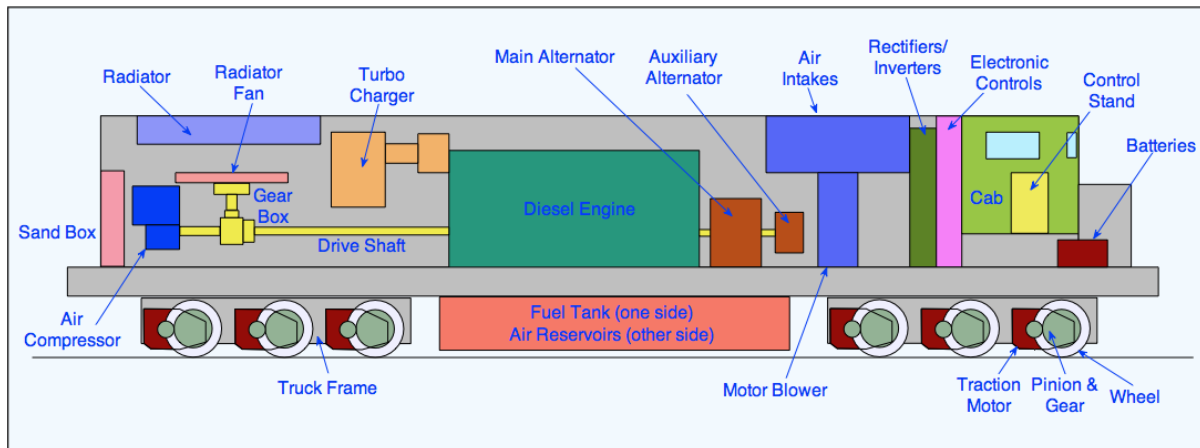
Figure 2.4 - Anatomy of a Diesel Electric Locomotive (Connors)

Locomotives act as the source of motive power for a train. They are powered by a combination of a diesel engine and an electrical generator. Locomotives are diesel electric to eliminate the need for a transmission and gearbox for the engine that would require at least thirty gears (Karim, 2001). The diesel electric engine has its power supplemented by a turbocharger. A turbocharger is a device that allows for more air to be pumped into the cylinders by taking the exhaust air and recycling it back. The engine uses the fuel to power everything inside the locomotive from the generators (alternators), to the radiator fan and air compressor. Compressors are used to stop the locomotive since the brakes use an air system to slow down. The generator turns the mechanical energy into electrical energy that is then used to power the traction motors on the locomotive. These motors are what actually move the train as they spin the wheels and propel the locomotive forward. The radiator fan powered by the drive shaft of the engine cools the water in the radiator and keeps the locomotive from overheating while running. The air compressor works to make sure the hydraulic brakes have power when needed (Connors).

Repairs of locomotives can be a complicated and costly process due to the complex electronics and engine systems involved. The systems are highlighted in the picture in Figure 2.4.

The main systems that are focused on during locomotive repair include the engine, radiator, fuel pumps, the electrical control systems and wiring, and the condition of the “bogies” or chassis (refer to Figure 2.4 above). Each system must then be reviewed for a multitude of possible problems. These reviews involve the above and below deck platforms to analyse different sections of the locomotives (Connor, 2016). The engines commonly require work, with pistons and cylinders being removed and replaced directly from the engine block. The replacement is due to the fact that the piston is continually pumping through the cylinder; this causes wear over time, and more petrol for the engine to work at the same rate causing of efficiency. After eight years, the cylinder needs to be fully replaced before it can be returned to the engine. The pistons and cylinder casings are longer lasting.

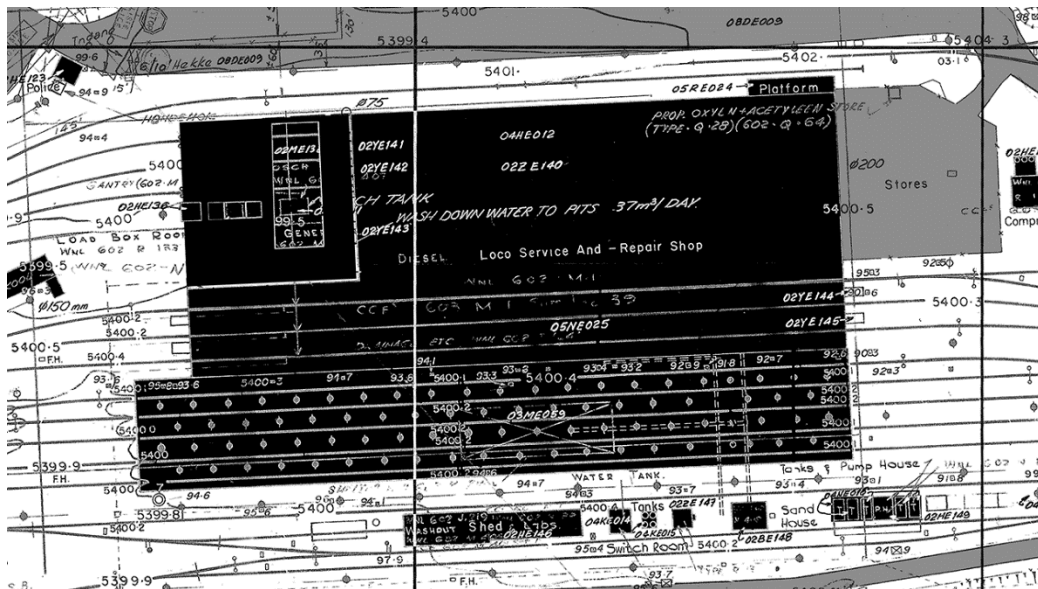
Figure 3.2 - Locomotive Repair Section

The repair workshop is divided into two different shops, one responsible for locomotive repairs and their required daily inspections and maintenance. The locomotive section can be seen below in Figure 3.2. The wagon section can be seen in Figure 3.3 and is responsible for rolling stock maintenance and repairs.

The locomotive workshop has two main buildings, one for heavy repairs and disassembly and the other for running repairs that can be completed without disassembly. The heavy repairs building is divided into 5 different sections; cleaning, wheel maintenance, engine maintenance,

electrical maintenance and running maintenance. The running repairs building consists of 3 platform tracks with room for 6 trains on each track. These tracks are built to allow for maintenance work above and below the locomotives.

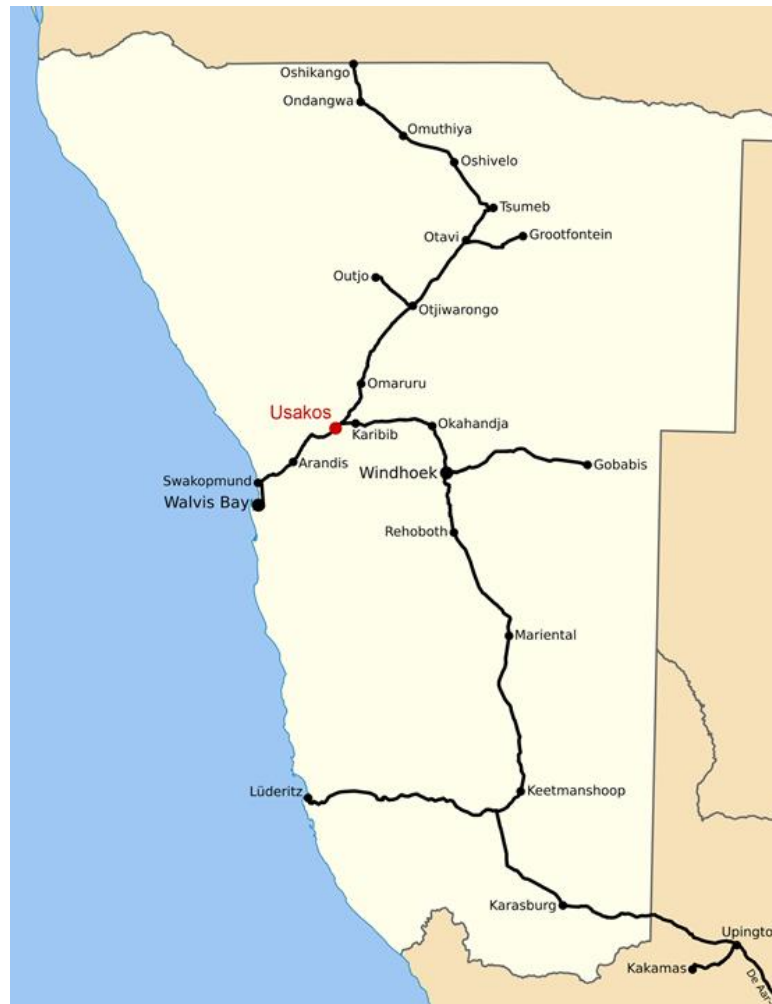
Figure 4.1 - Rail map including Usakos

During colonial times, a steam locomotive repair shop was created in Usakos, about 166 Km north west of Windhoek (highlighted by the red dot on the map in Figure 4.1), where locomotives and rolling stock were serviced until the 1960's (Dierks, 2004).

TransNamib trains still pass Usakos frequently, but the station building and repair workshop are abandoned and in serious disrepair. The town of Usakos was created due to its geographic importance as a strategic junction in the rail system, since it is located along the main corridor of rail travel in Namibia, from the Port of Walvis Bay north to Tsumeb and the Angolan border, as well as to the eastbound line to Windhoek. This central location makes it accessible to the majority of rail traffic in the country.

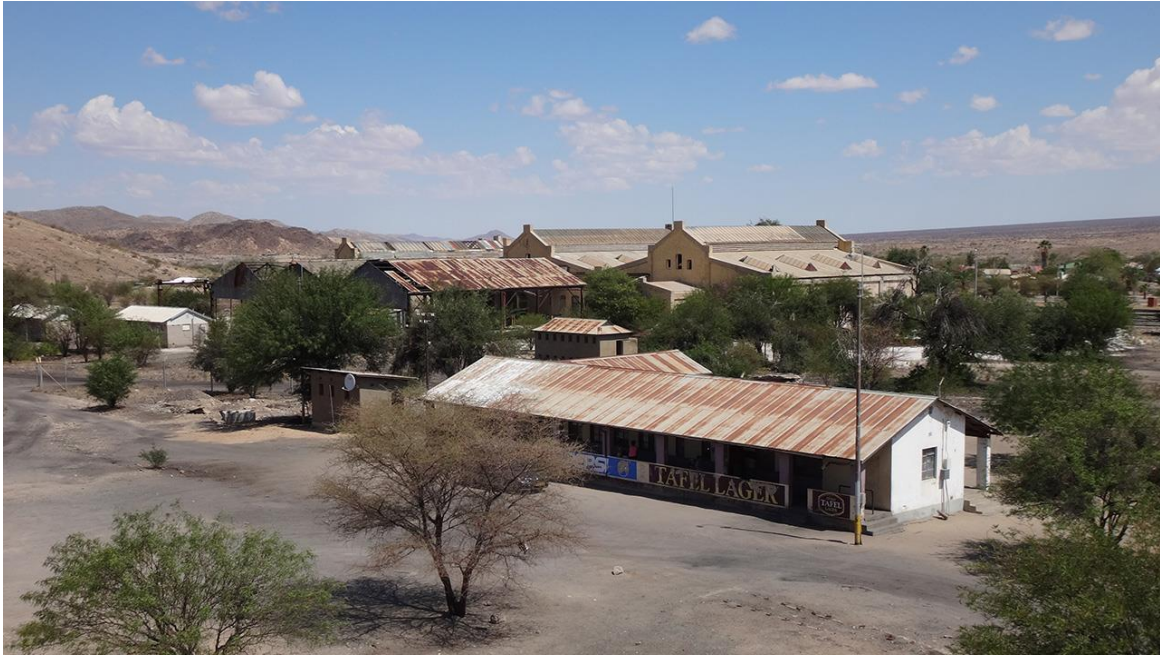
*Figure 4.2 - Usakos Buildings*

The group was then able to inspect the land owned by TransNamib to get a detailed understanding of what is left of the original steam train repair shop (Figure 4.2). We recorded which structures could be adapted to our new design along with what would need to be demolished. Additionally, we acquired engineering drawings of the area with details about the former shop. Based on these documents we were able to identify changes to the current structures and other design constraints.

The remnants of a metal shed and the empty walls of the larger repair workshop can be seen in Figure 4.3, along with a large empty space where tracks used to run. The site contains a large flat portion of land overgrown with vegetation and trees. Standing beside this area are two large water towers, which when inspected, appeared reusable for the new workshop. Sitting opposite the surviving workshop building across the empty land sits a long thin building, which appears too small for any repairs but could be reused as office or living space. As a result of our visit, we concluded that the land is well suited for the placement of a new shop and that almost all the infrastructure will need to be rebuilt.

Although there is one large building that was formerly used for the heavy repair of locomotives that remains structurally intact, it is too small to be used for today's diesel electric locomotives, which are larger and heavier than their steam powered ancestors. Nevertheless, given the size of the structure, we concluded that the extant building would be a reasonable location to stage wagon repairs for the new repair shop.

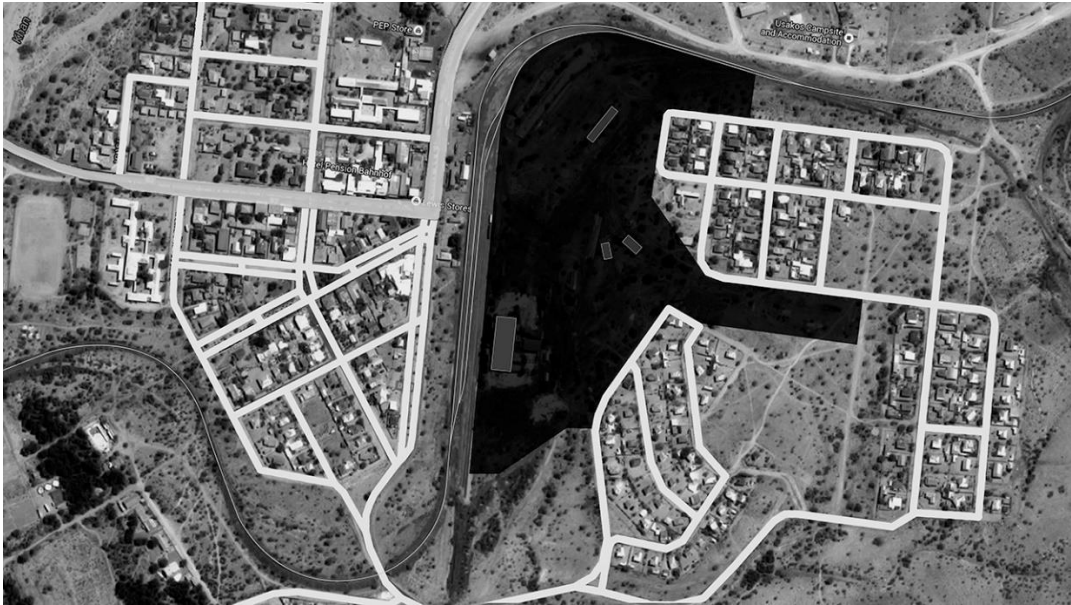
Figure 4.4 - Area with Design Constraints

The final constraint map is shown in Figure 4.4 below.

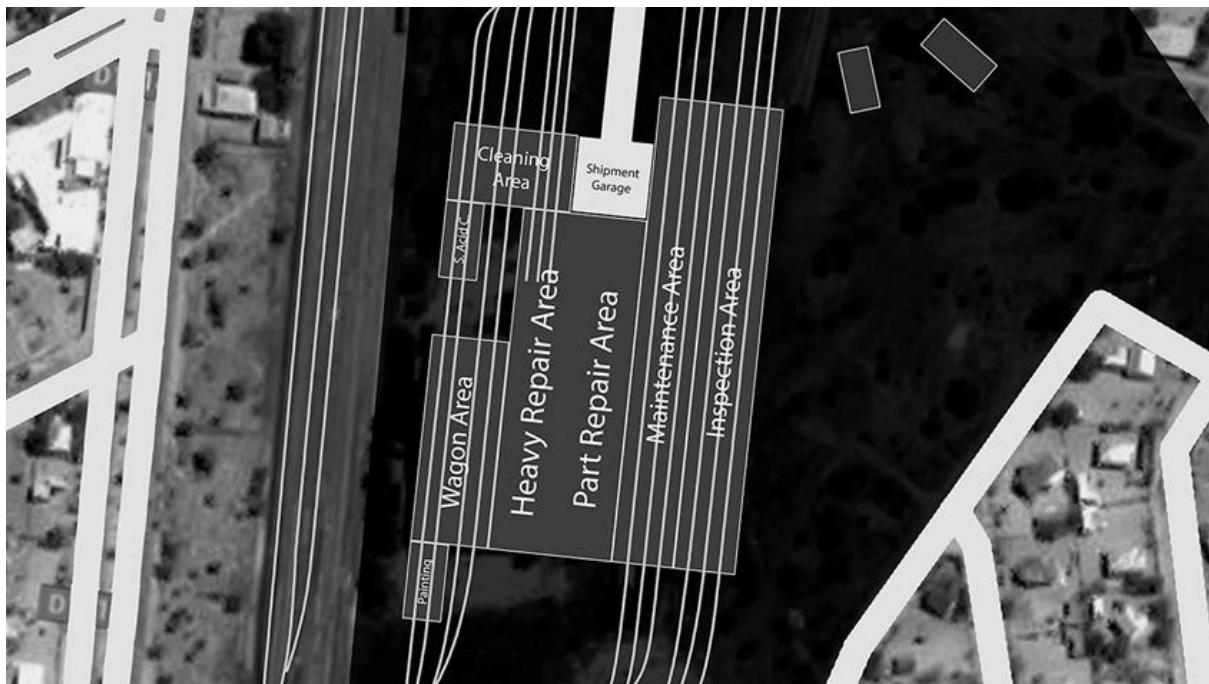
Figure 4.5 - Essential Workshop

The existing large building in the south was allocated to the **wagon area**. We were not able to analyse the structural condition of the building and leave the decision to TransNamib civil engineers on whether or not it will be used. To connect the repair workshops, the locomotive **maintenance** and **inspection** areas were placed in parallel with the wagon shop. In between these two main buildings, we placed the **repair shops** so that they could service both wagons and locomotives with minimal wasted movement of people and parts. The wagon and locomotive halls would have a total of ten tracks that would run through the entire building, entering at one end and exiting at the other end to allow first-in-first-out processing of repairs with no backups.

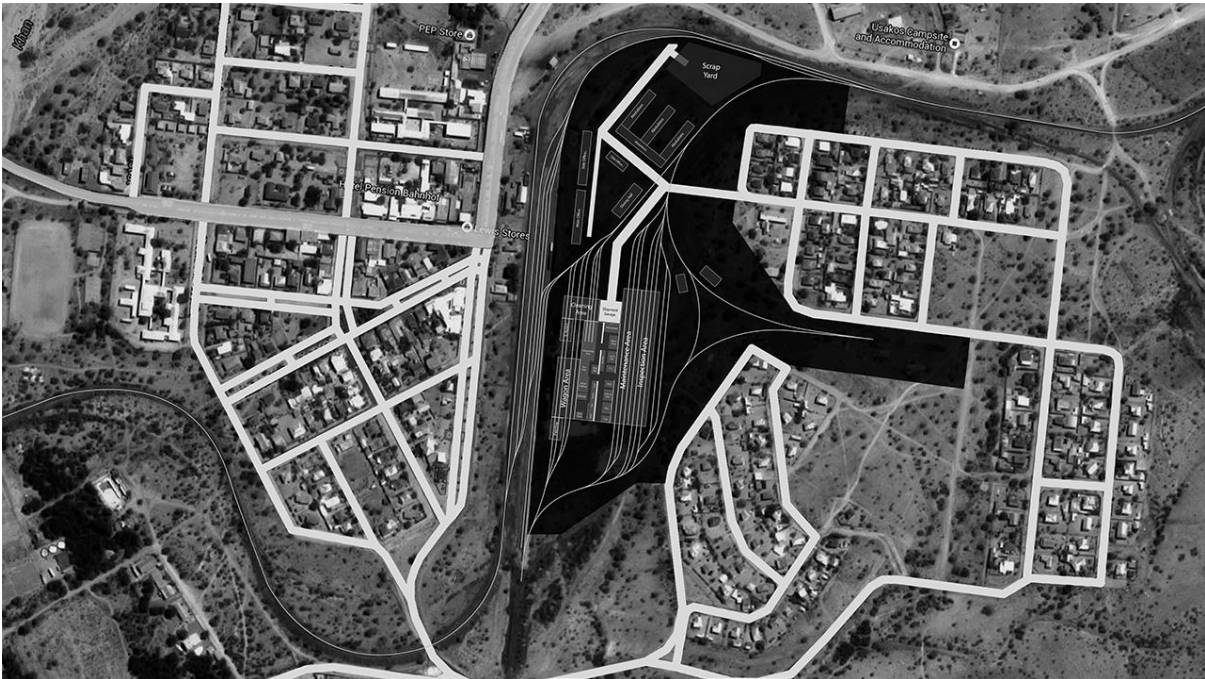
Figure 4.7 - The General Design with Rails and Roads

The **rail tracks** were laid out to allow the efficient shunting and repair of locomotives and wagons. The workshop has two entrances, one from the West and one from North, for trains approaching from the eastern side. There are secondary rails to safely take trains from these connections to each of the individual workshop areas. The large triangle on the east of our workshop serves as a convenient three-way turn for trains. In all, we calculate that 6.7 Km of new rails will have to be installed in the new workshop. The general layout design with main rail and road lines can be seen in Figure 4.7.

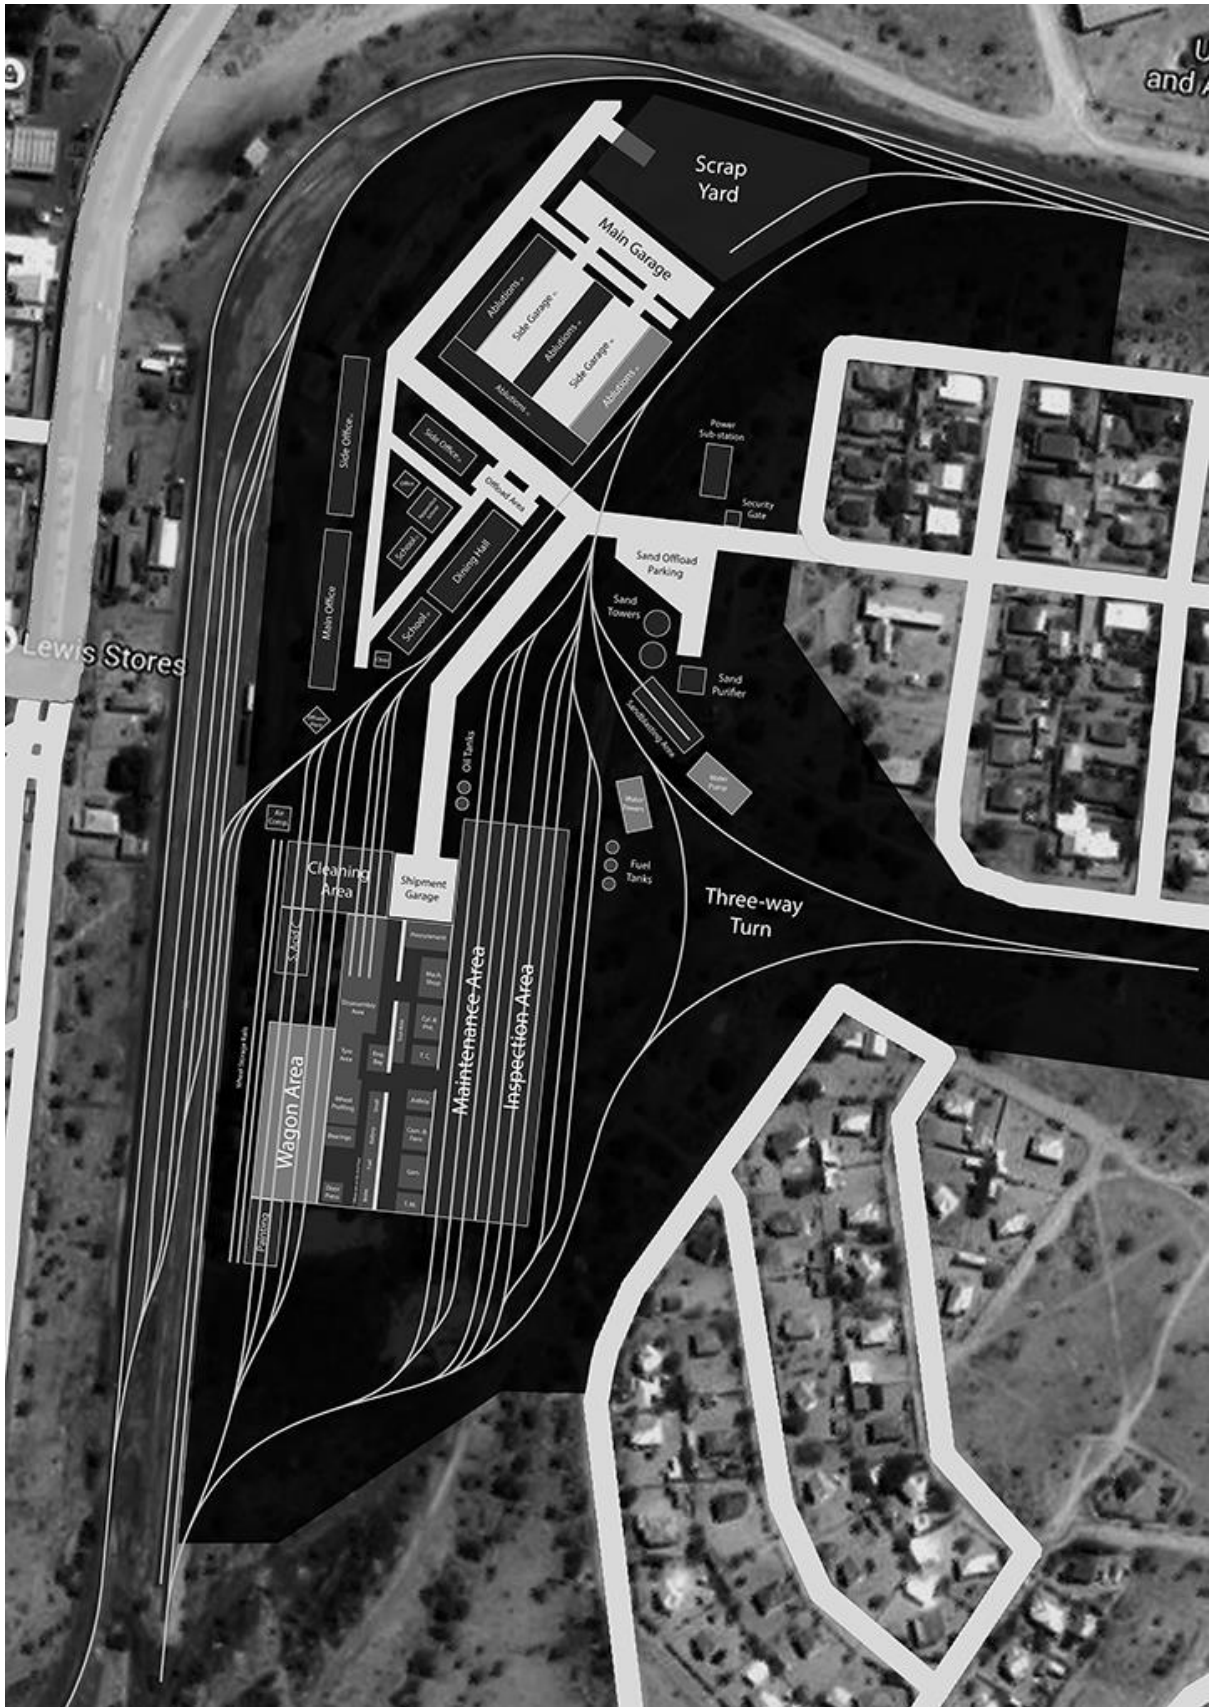
Figure 4.8 - Final Exterior Design

The final step in our designs was to add the **minor buildings**. First we added structures to handle water. Two large **water tanks** and a **water tower** are still in operational today and were integrated into our designs. It is necessary to pipe clean water from these structures to supply offices that are both in the main workshop and also the secondary areas. There must also be an **effluent plant** to deal with unclean water contaminated by various processes in the shop. Since laying out pipes is a simple process, we suggest straight lines, with minimal branching, from water tanks and the effluent to the supply and remove water from the structures.

Other necessary supplies include **oil** for locomotives and **fuel** for engine operation. We have dedicated tanks for both, which are neighbouring the inspection area, giving easy access to these structures. Our final exterior design including all Workshop support structures can be seen in Figure 4.8.
