USE OF MAGNESIUM ALLOYS IN TENSION BAND WIRING OF OLECRANON FRACTURES

A Major Qualifying Project Report Submitted to the Faculty of the
WORCESTER POLYTECHNIC INSTITUTE

In partial fulfillment of the requirements for the
Degree of Bachelor of Science
in Mechanical Engineering

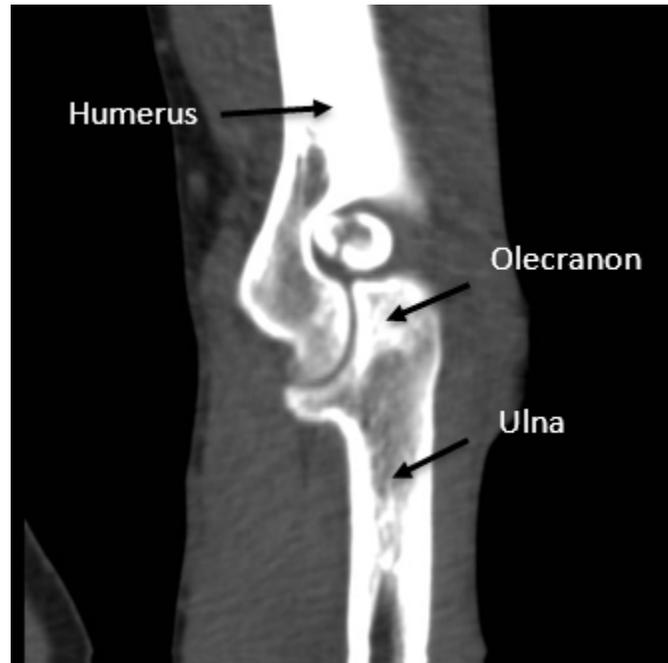
CT scans of a healthy elbow were obtained (Worcester County Orthopedics, Worcester, MA). An example of a CT scan is shown in Figure 3. The CT scans were converted into a 3D computer model using Mimics software (Medical version 16).

Figure 3: CT scan image of a normal elbow joint

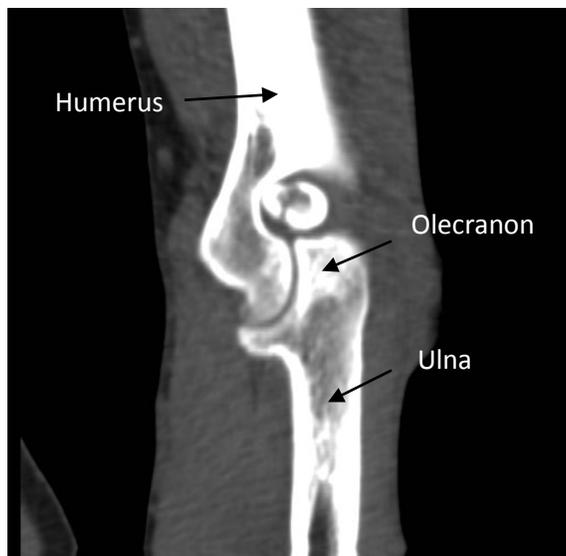
CT scans of a healthy elbow were obtained (Worcester County Orthopedics, Worcester, MA) to be converted into a 3D computer model of an ulna with a transverse olecranon fracture. An example of a CT scan image of a normal elbow joint is show in Figure 2.

Figure 2: CT scan image of a normal elbow joint without fracture
